Environmental Monitoring Report for In-Stream Work

Prepared by: Olin Albertson, Avison Management Services Ltd.

December 21, 2015

Project: Larson Road Culverts Replacement (Murray Creek KP10+000)

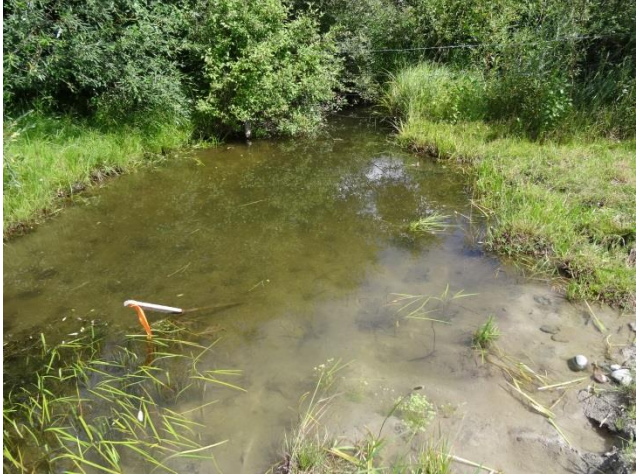
Pre-work photo of outlet looking upstream.

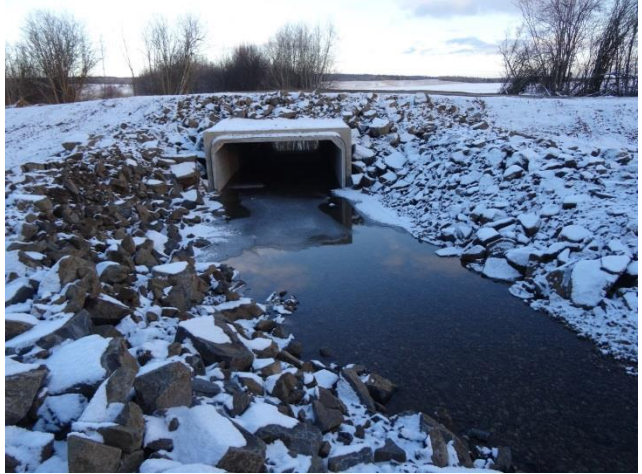
Post-work photo of outlet facing upstream.

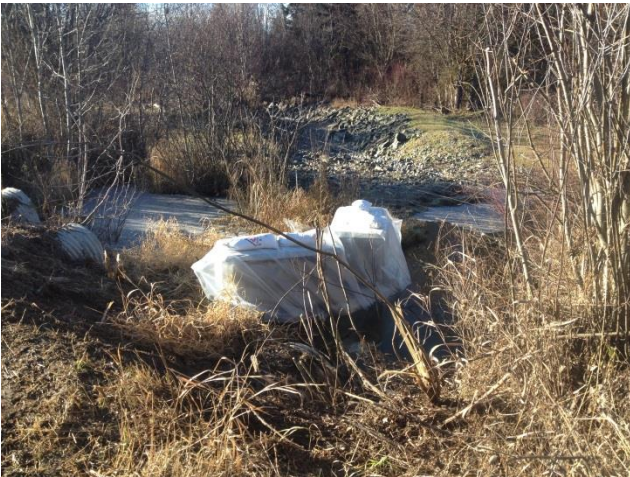
Pre-work photo of outlet looking downstream.

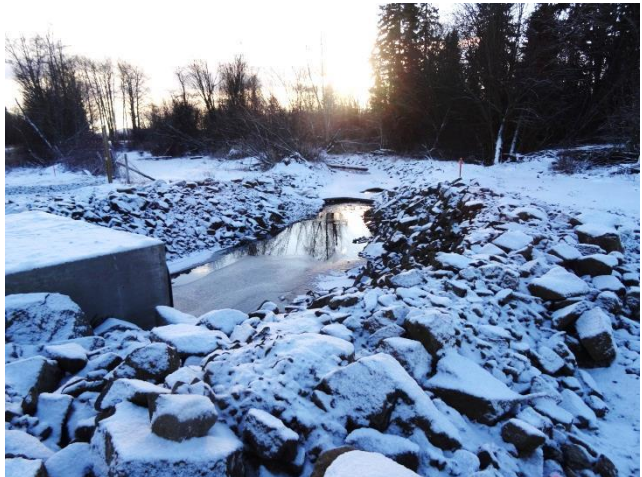
Post-work photo of outlet looking downstream.

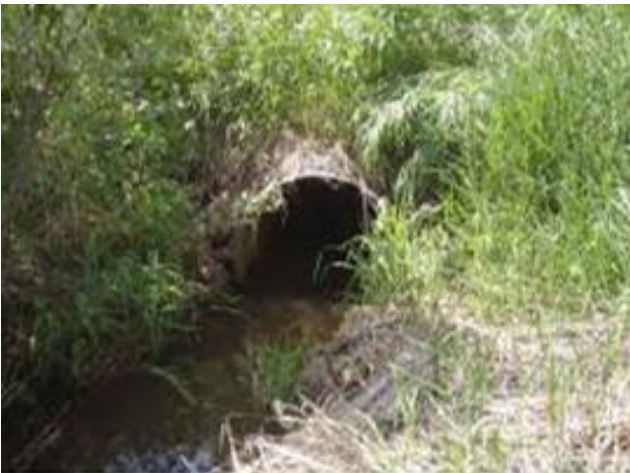
Pre-work photo of the inlet.

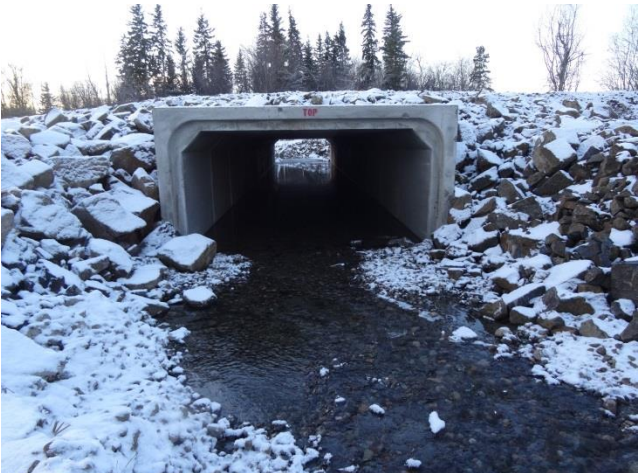
Post-work photo of the inlet.

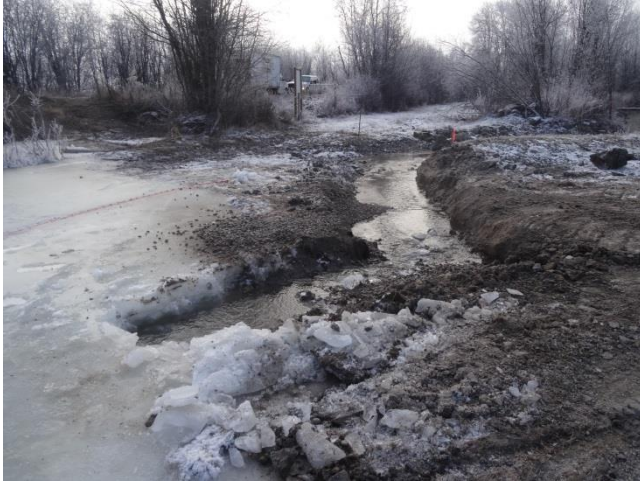
Partial diversion of existing stream into new channel.

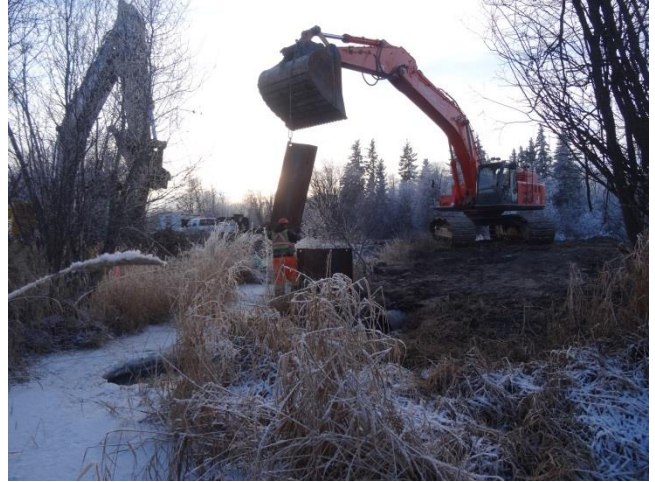
Placement of sheet piling for site isolation.

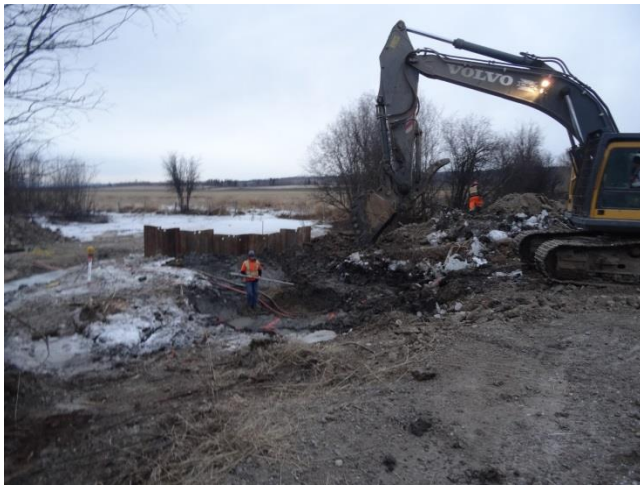
Commencement of culvert excavation following fish salvage.

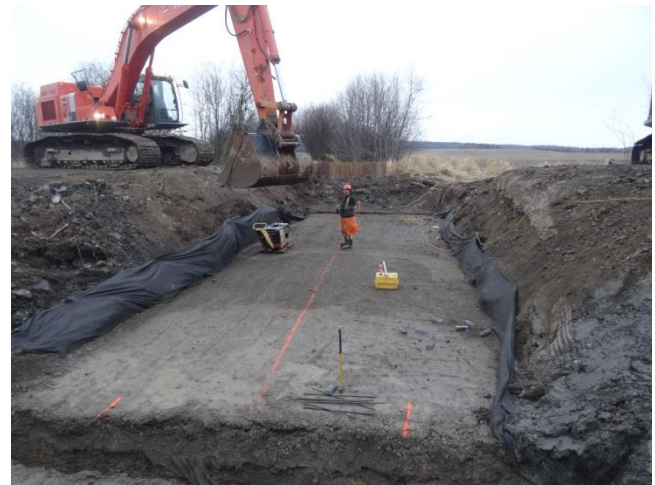
Nearing completion of new culvert bed.

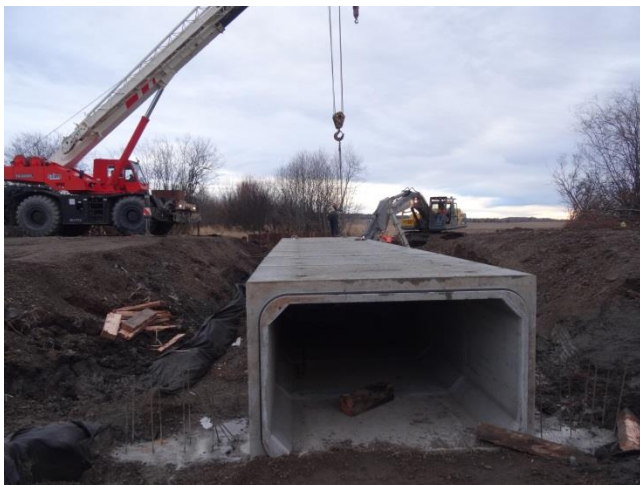
Placement of new culvert.

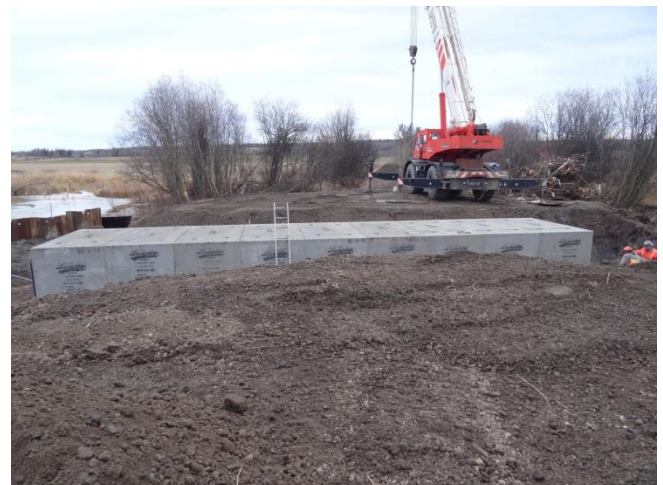
Nearing completion of new culvert placement.

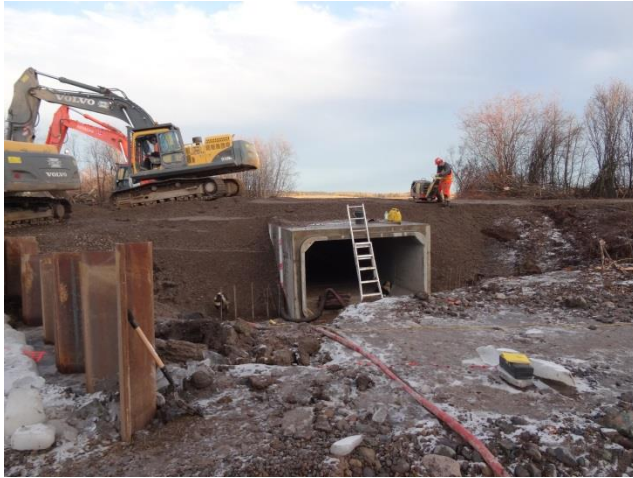
Placing and compacting culvert fill.

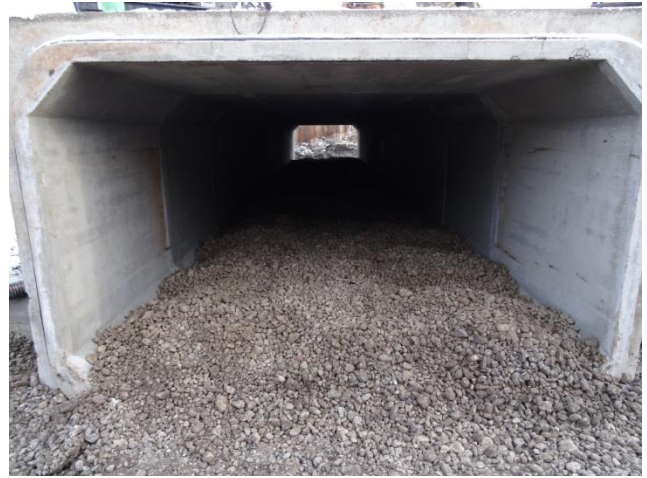
Placing specified substrate in culvert.

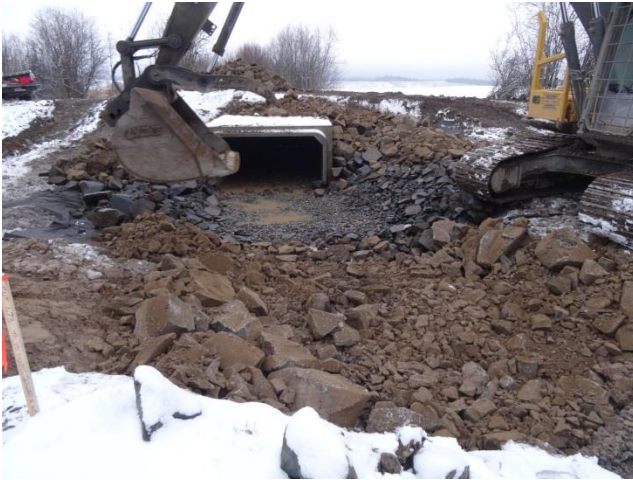
Placing and washing of riprap (outlet).

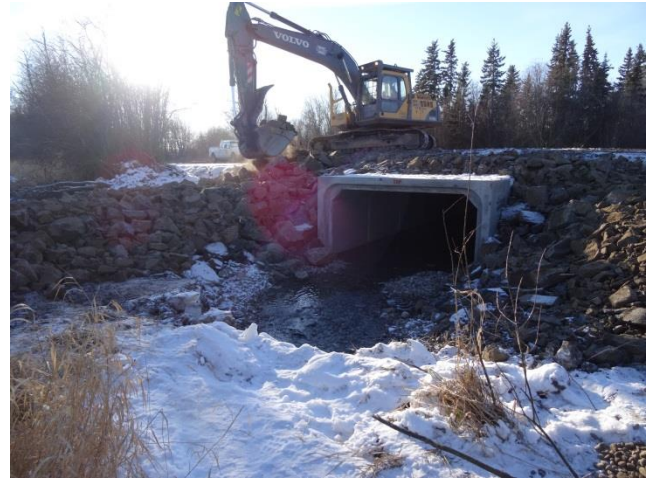
Final placement of riprap at inlet.

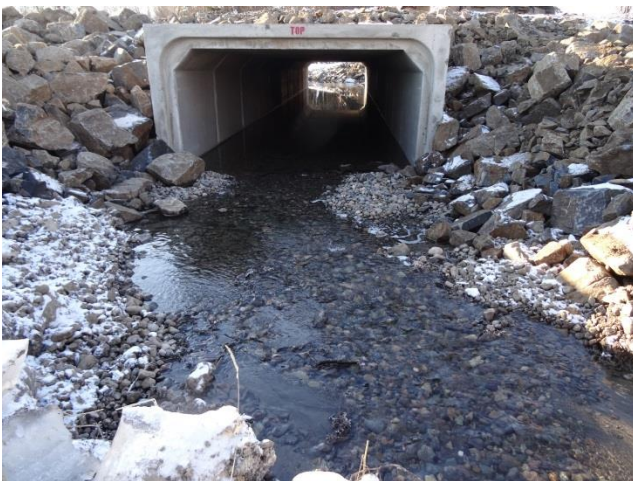
Release of water through the culvert when clean.

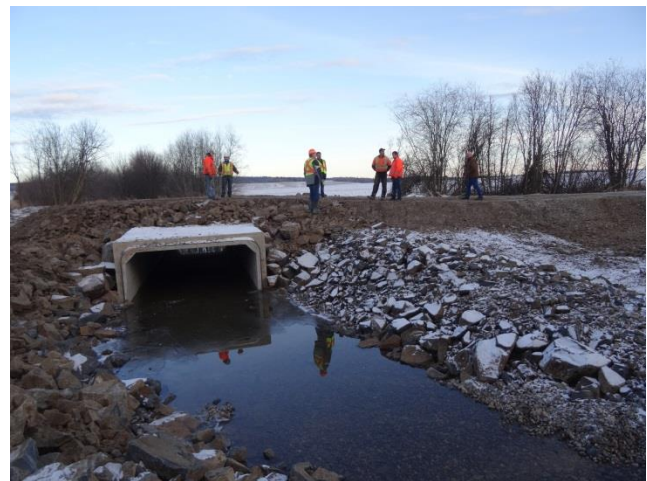
15:00 – MOTI engineers, YRB, NEWSS, Van-Con, and Avison all on site for MOTI inspection. Everything checks out okay. Seeding and placement of straw for erosion protection recommended.

MOTI inspection of works.
