Stoney Creek

Preliminary Watershed Health Assessment

Olin Albertson R.P.Bio
Avison Management Services Ltd.
P.O. Box 774
220 East Stewart St.
Vanderhoof, B.C. V0J 3A0
Ph: (250) 567-2111

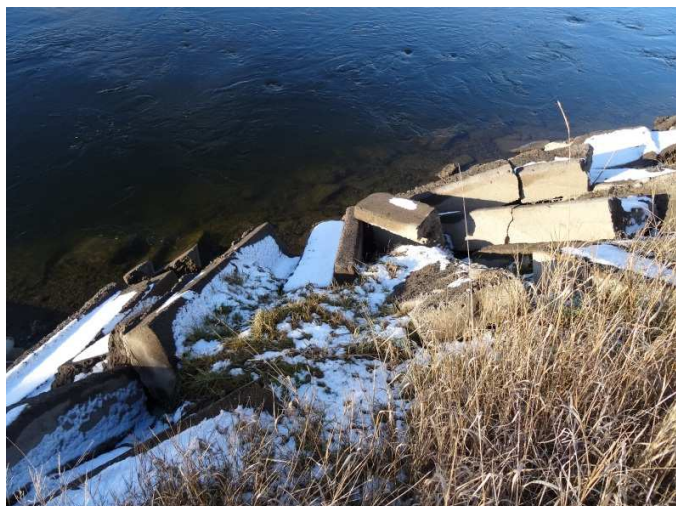
Photo 3: Concrete and metal scrap along bank

It is currently unknown who is responsible for these actions. What is known is that this site is in need of attention and remediation efforts should be considered. The old cars, scrap metal, concrete, garbage and debris should ideally be cleaned up and removed from the river if this can be done with minimal disturbance to the river substrate and bank, and with minimal sediment suspension instream. The old cars, airplane parts, scrap metal, and concrete have had some functionality in reducing erosion and providing bank stability and should be replaced with approved acid free rip-rap to prevent erosion and provide bank stabilization.

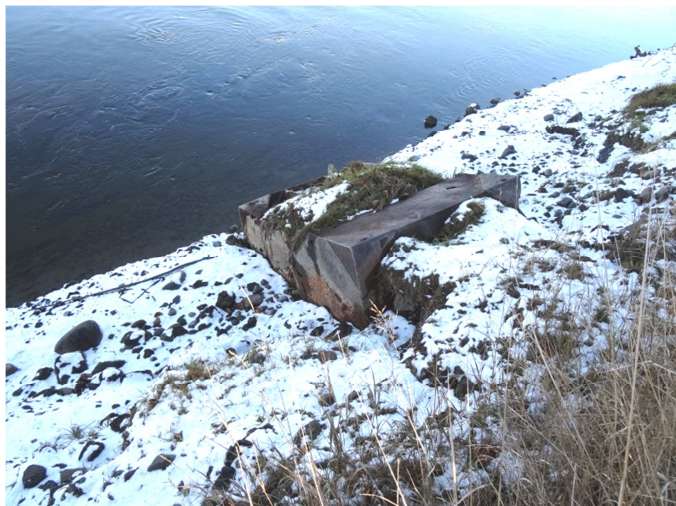
Photo 5: Metal scrap along bank

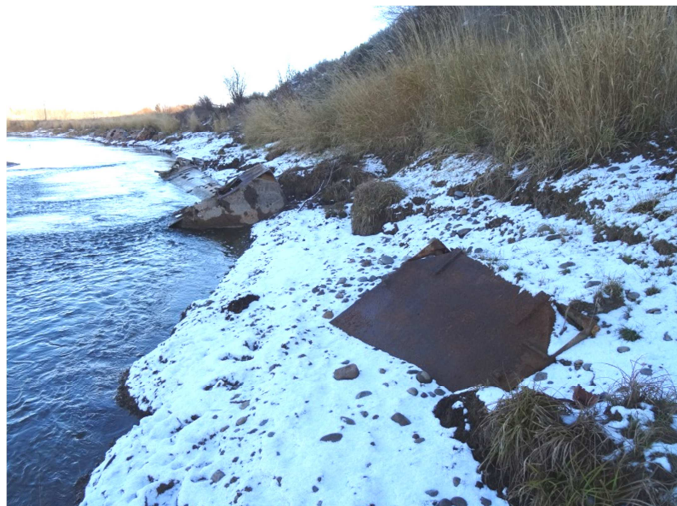
Photo 6: More metal scrap along bank

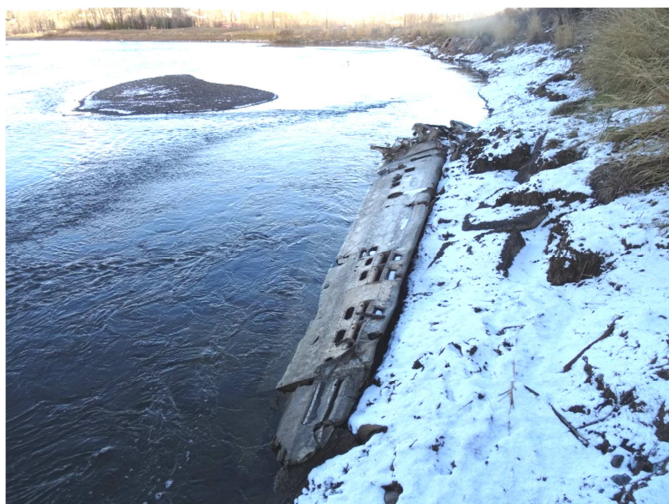
Photo 7: Aircraft wing along bang

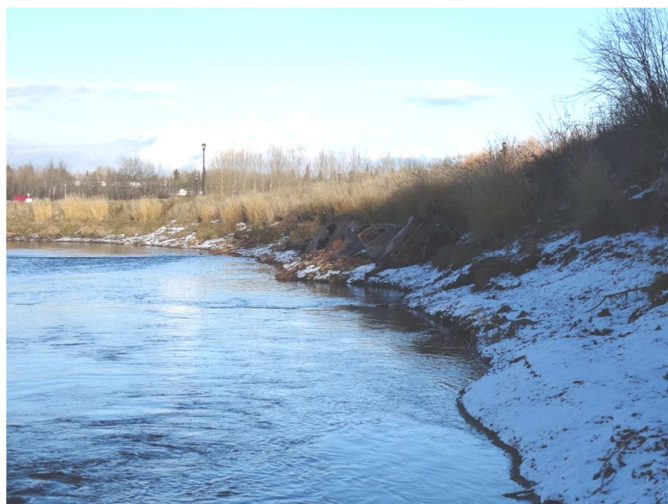
Photo 8: Looking downstream at abandoned cars

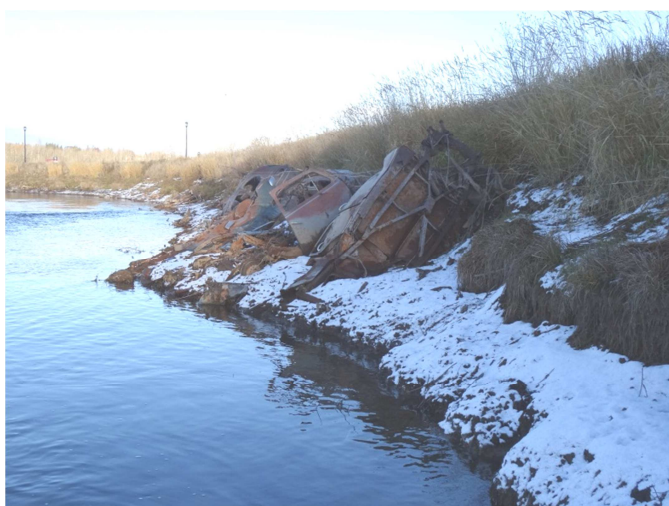
Photo 9: Close-up of abandoned cars

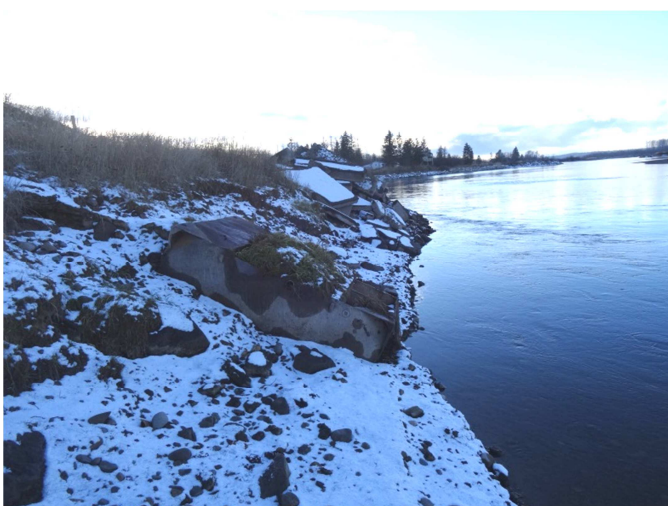
Photo 10: Looking upstream at scrap metal

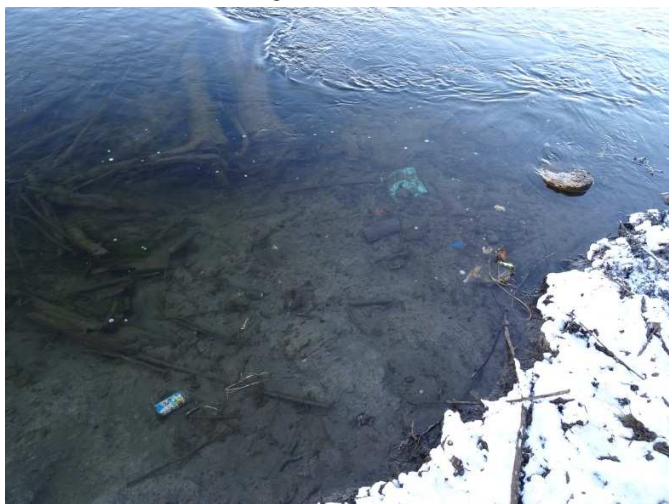
Photo 11: Garbage and debris in the water

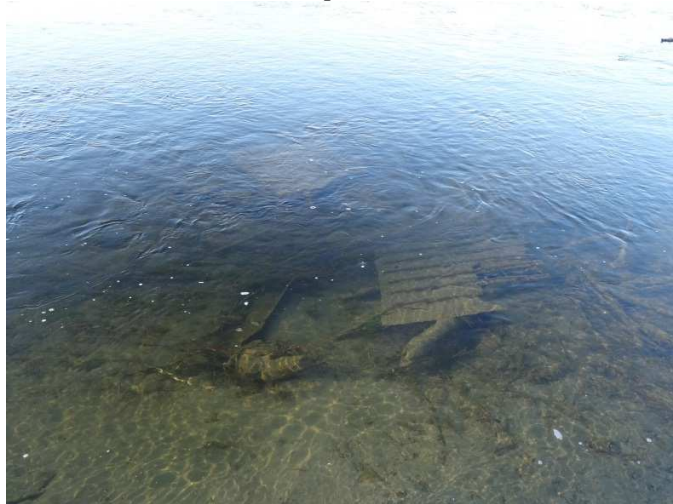
Photo 12: More metal scraps in river

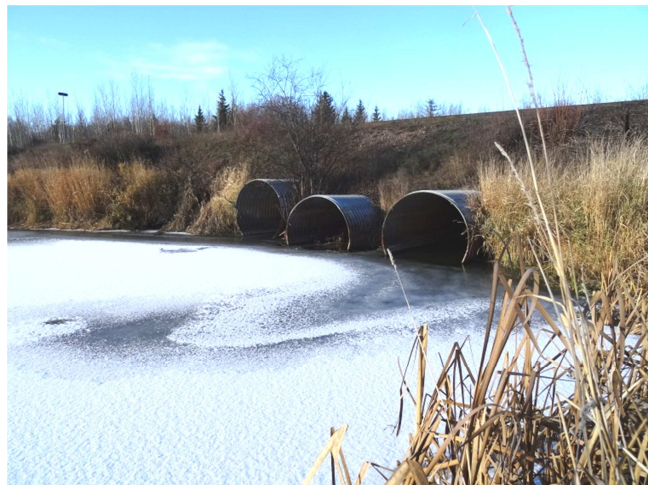
Picture 1: Culvert Inlet

There are three round closed bottom culverts at this site. It appears, that these culverts were placed so that during freshet when high water velocities are coming out the culvert outlets, water is forced into the Northwest bank causing the bank to erode. All three culverts have a partial blockage inside the culverts caused by beavers. These blockages are causing the stream to be backed up upstream for several hundred meters. Even without these blockages, it appears the culverts inlets are raised to high, and water would be still be backed up upstream although at a lower water level. The lowest of the three culverts has a 15 cm outlet drop, and the other two culverts are higher and are likely fish impediments at low water and during spring freshet before the Nechako River water levels have risen. Fish passage may be possible when the Nechako River flows are high enough to back water up and slow velocities through the culverts however under normal and freshet conditions these culverts are likely barriers to fish. These culverts were assessed as barriers and are in definite need of replacement.

- 1) Take out the culverts during low flow and replace them with a bridge.
- 2) Replace these culverts with a large diameter open bottom arch culvert that will handle freshet flows and will not impede fish passage.
- 3) Additionally, the Northwest bank downstream of the culvert needs to be armoured to prevent further erosion. This could be accomplished with a combination of rip-rap, rock-toe and tree revetments, root wad deflectors, or other options.

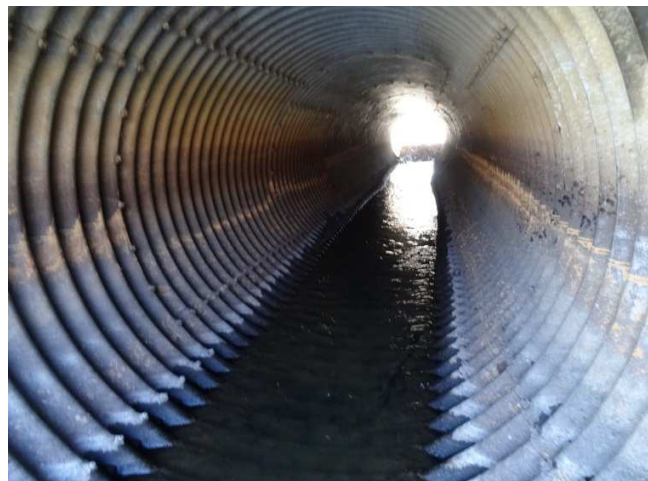
Picture 5: Culvert Barrel

Crossing Fix	Recommended Diameter or Span (meters)	Assessment Comment
Open Bottom Structure	25	Three culverts, all the same size. Beavers have dammed inside of the culvert. Water is backed up above the culverts

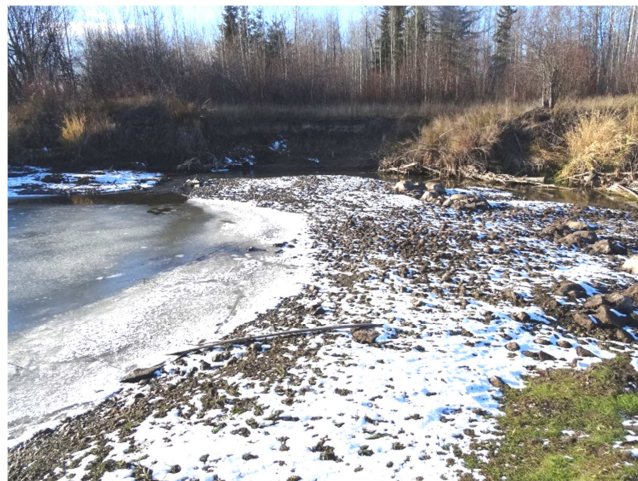
Picture 6: Down Stream Bank Erosion

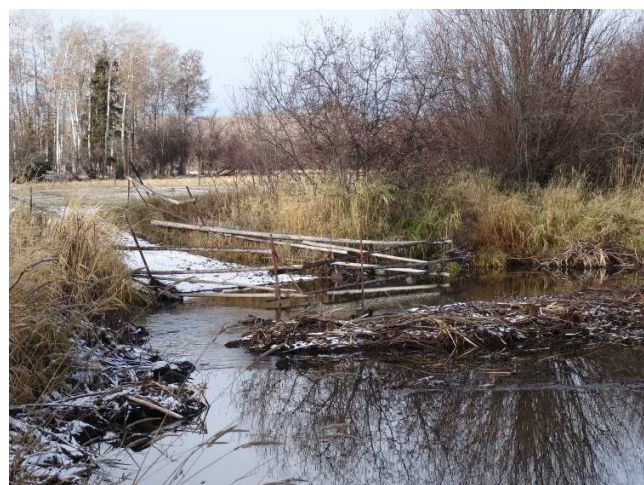
Picture 6: In stream cattle watering site

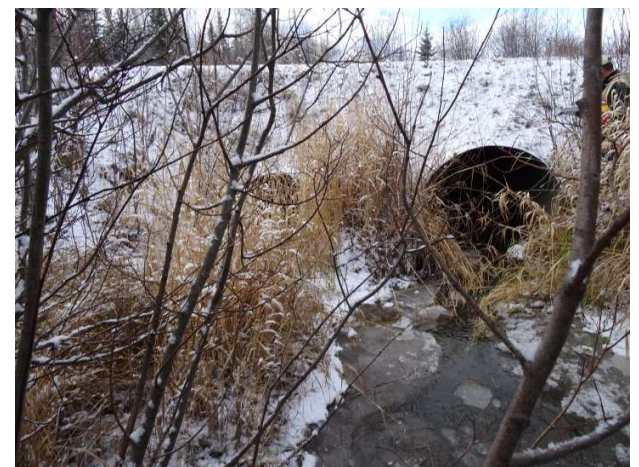
There are two closed bottom culverts at this site, one main culvert, and a smaller overflow culvert. The stream width ratio for this culvert indicates it is inadequate for this stream. In addition, some of the other assessment attributes (culvert length, embeddedness, and slope) make this culvert score as a barrier to fish. There was no evidence of washouts occurring, or severe erosion in past years. There is little evidence of beaver activity near the culvert. This culvert scores as a barrier and should be replaced.

Picture 6: Culvert Outlet with Both Culverts

- 1) Take out these culverts during low flow and replace them with a bridge.
- 2) Replace these culverts with a large diameter open bottom arch culvert that will handle freshet flows and will not impede fish passage.
