Omineca - Peace Region

Region 7. Omineca-Peace

Spruce Creek Stream Restoration Project: Horses and Helicopters

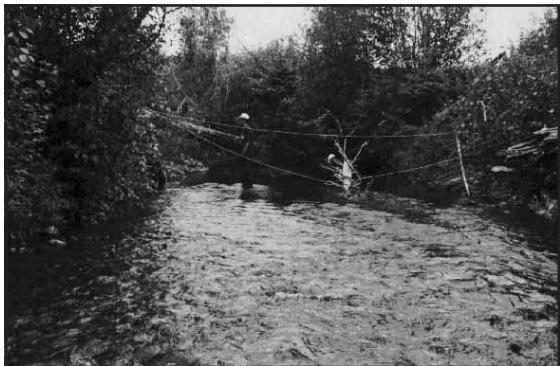
Figure 7-2. Site 7. Pre-restoration. Exposed banks, extended riffles, and lack of pool cover were predominant throughout the lower reaches.

Figures 7-2 and 7-3 portray the pre- and post-effects at site 7. Here, restorative actions were done to create a boulder garden and bank deflector as well as a pool complex. Figures 7-4 and 7-5 show the pre- and post-treatment effects

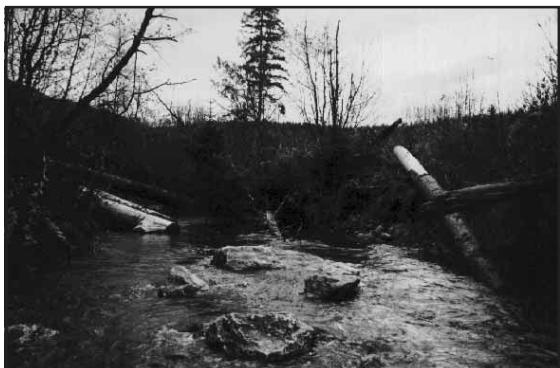
Figure 7-3. Site 7. Post-restoration showing the addition of bank deflectors, LWD in pools, and a boulder garden.

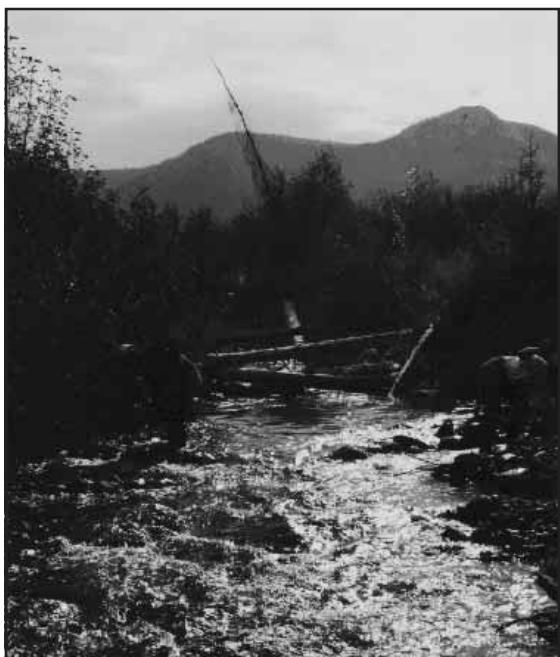
Figure 7-4. Site 9/10. Pre-restoration indicating channelized sections and current LWD breaking down in a small jam upstream.

of opposing wing deflectors at site 9, as well as jam enhancing upstream at site 10. Figure 7-6 is an example of a Hewitt ramp at site 13.

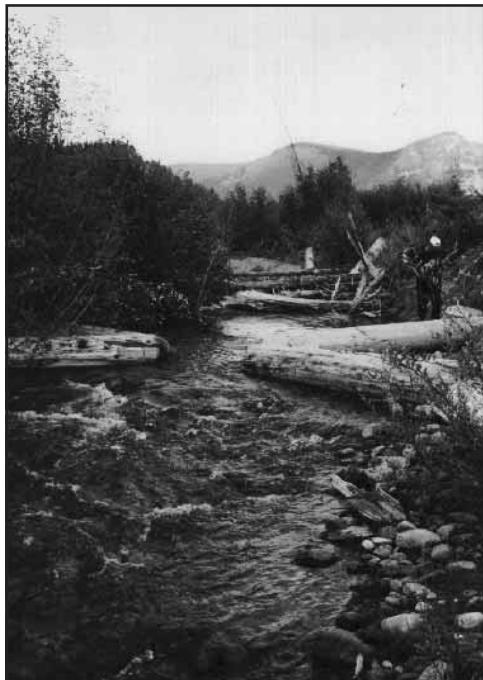
Figure 7-5. Site 9/10. Post-restoration photo of stabilized opposing V-wing deflectors, creating pool habitat, focusing scour, and reducing flow velocities throughout the habitat units.

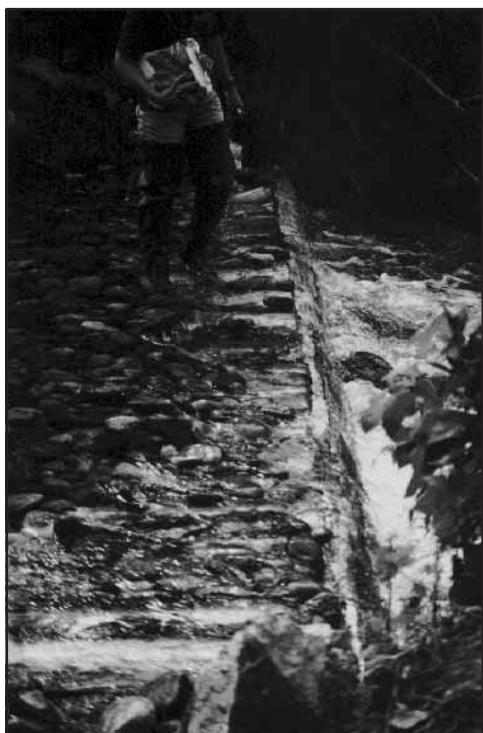
Figure 7-6. Site 13. A Hewitt ramp structure was constructed in a long riffle section. Cedar logs were manually sawn to create 8 foot cedar planks on the ramp. The restored site now provides deep backwater pools and an overall increase in wetted habitat and cover under the structure.

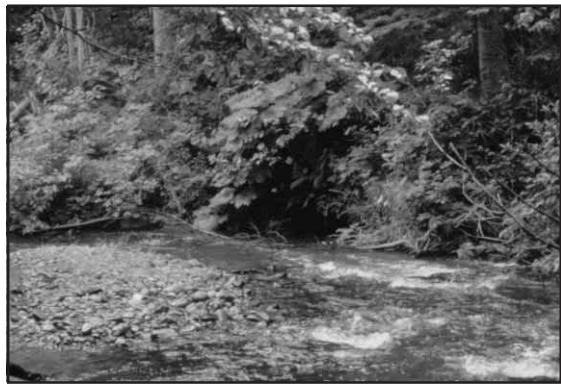
Figure 7-7. Pre-restoration photograph of McPhee Creek, Reach 2 site 5. Note absence of woody debris cover in pool.

size compared to Reach 3, focused on enhancing pre-disturbance LWD jams that were beginning to deteriorate and become nonfunctional. Additional treatments included placement of LWD debris catchers in existing pools (Figs. 7-7, 7-8) as per Slaney et al. (1997), armoring eroding banks with rootwads and LWD (Figs. 7-9, 7-10) and the addition of boulder complexes along glides to increase habitat complexity for juvenile salmonids (Fig. 7-11). Prescriptions in Reach 3, characterized by a complete loss of LWD on both banks, were similar to those described in Reach 2.

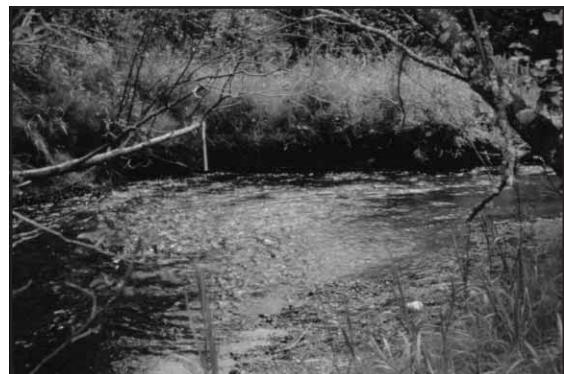
Figure 7-9. Pre-restoration photograph of McPhee Creek, Reach 3 site 6. Note localized area of bank erosion on outside of bend.

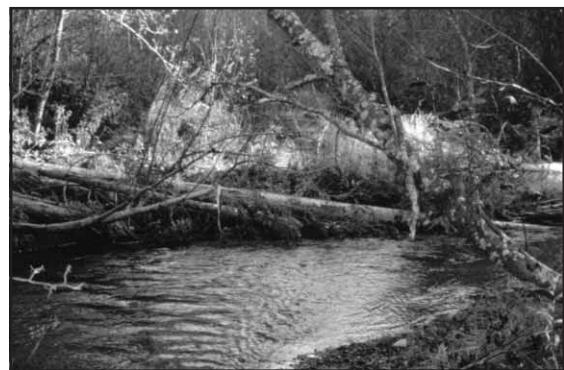
Figure 7-10. Post-restoration photograph of McPhee Creek, Reach 3 site 6. Large woody debris and boulders armoring area of bank erosion and providing overhead cover.

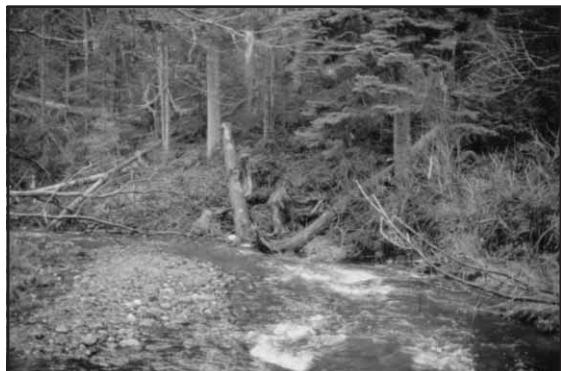
Figure 7-8. Post-restoration photograph of McPhee Creek, Reach 2 site 5. Lateral triangular large woody debris structure constructed in pool to provide overhead cover and induce additional scour.

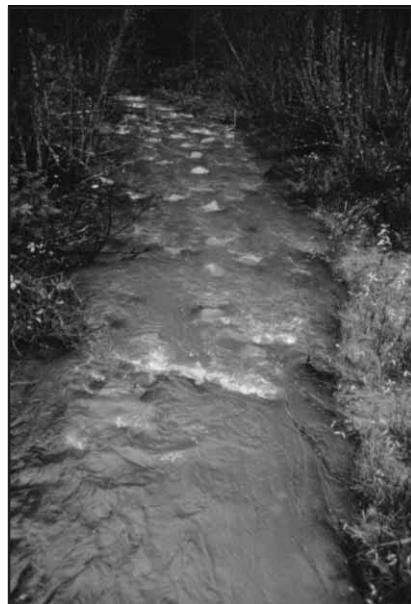
Figure 7-11. Post-restoration photograph of McPhee Creek Reach 2 site 4. Note boulder clusters in groups of four placed in mid-stream channel to provide juvenile rainbow trout rearing habitat.

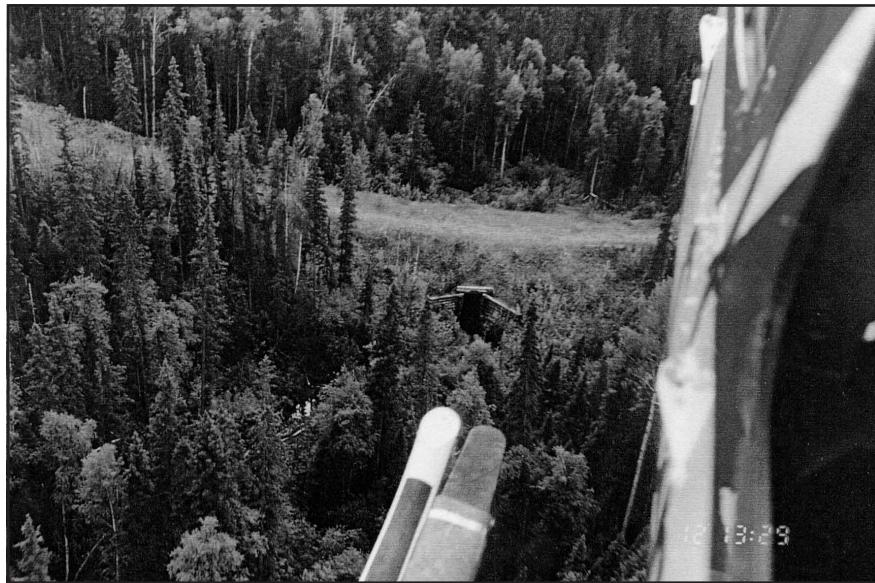
The assessment indicated a 3 m² by 28 m long log box culvert was blocking fish passage (Fig. 7-13). At a moderate discharge the water entering the culvert traversed half the culvert length before disappearing through the log floor. The outlet was also perched 20 cm above the creek surface (Fig. 7-14). Restoring fish passage would allow access to 12 km of high quality stream habitat. The restoration prescription was to remove the crossing and re-establish a natural stream bottom and stable banks (because the road was inactive and the logs deteriorating).

Figure 7-13. Aerial view of the box culvert crossing on Stubby Creek.

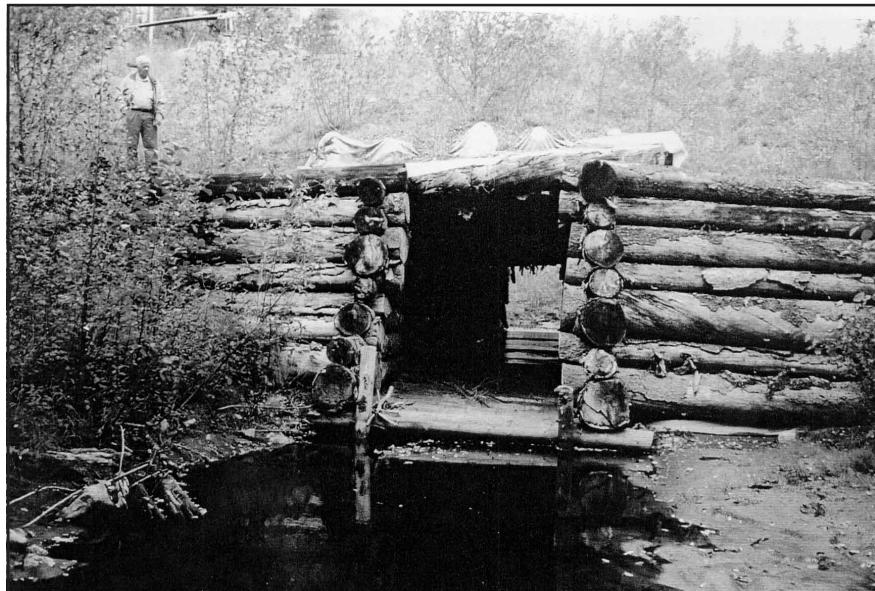
Figure 7-14. A view of the outlet of the box culvert crossing on Stubby Creek.

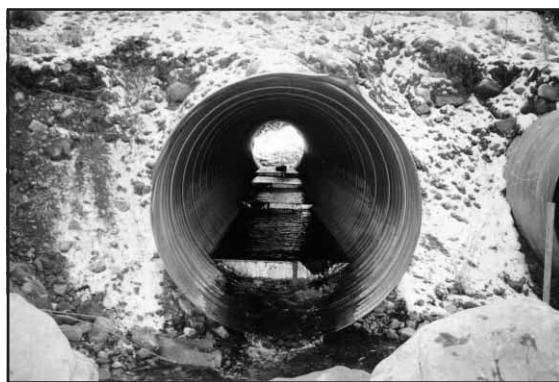
Figure 7-15. Upstream view of crossing #1 with the baffles installed in the culvert but prior to construction of the downstream riffle.

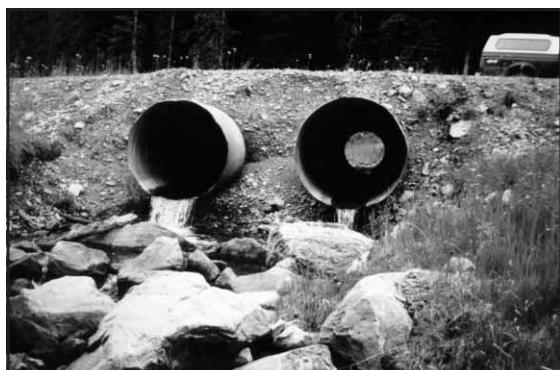
Figure 7-16. Upstream view of crossing # 2 before restoration.

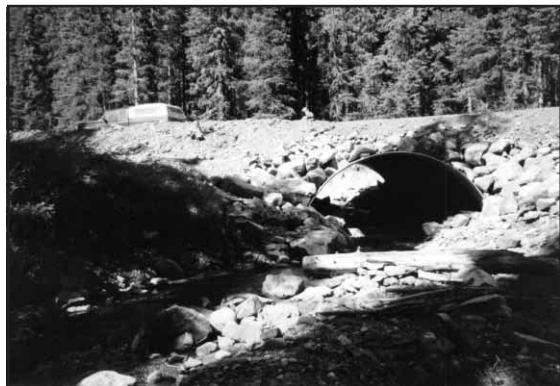
Figure 7-17. Downstream view of crossing #2 following replacement with a bottomless arched culvert.

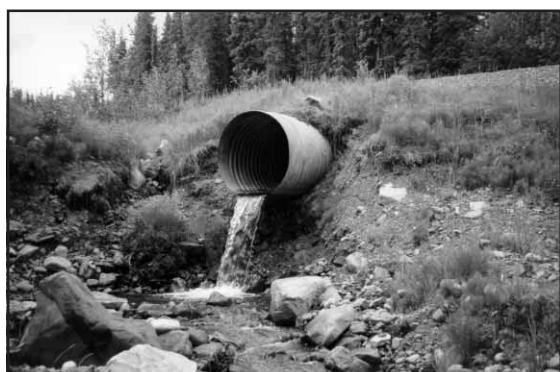
Figure 7-18. Upstream view of crossing #4 before restoration. Note the 1.5 m drop at the outfall.

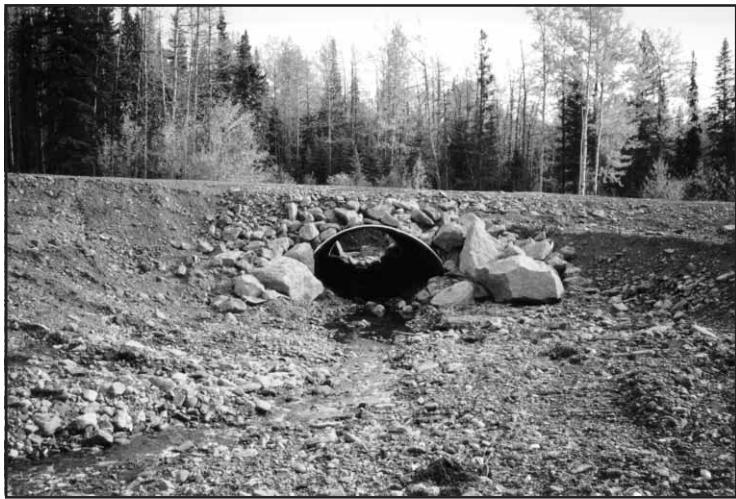
Figure 7-19. Downstream view of crossing #4 following replacement with a bottomless arched culvert and recontouring of the streambed.

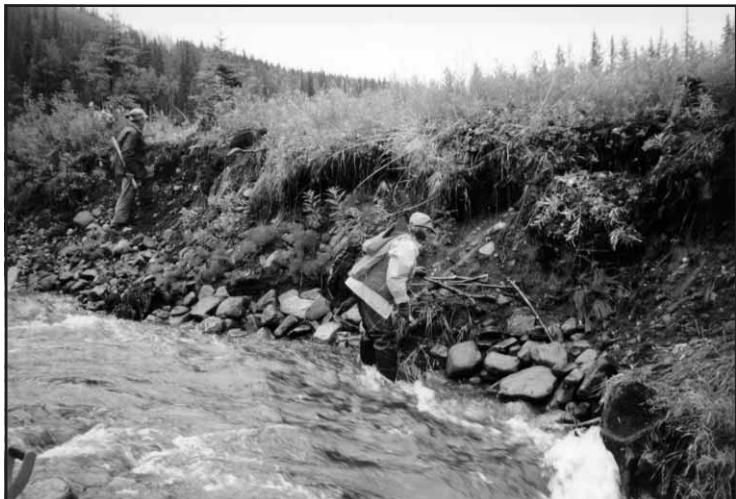
Figure 7-20. Horizontal willow staking of an eroding cutbank on Blue Grave Creek.

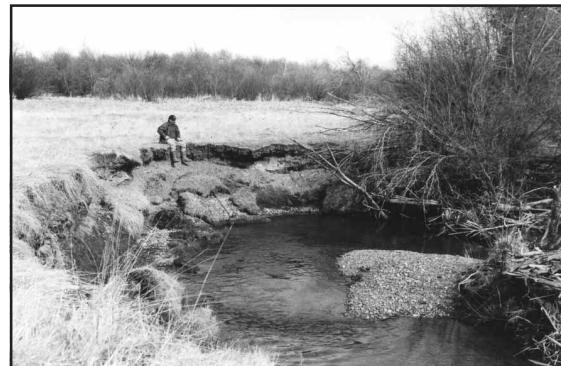
Figure 7-21a. Before restoration of an eroding bank.

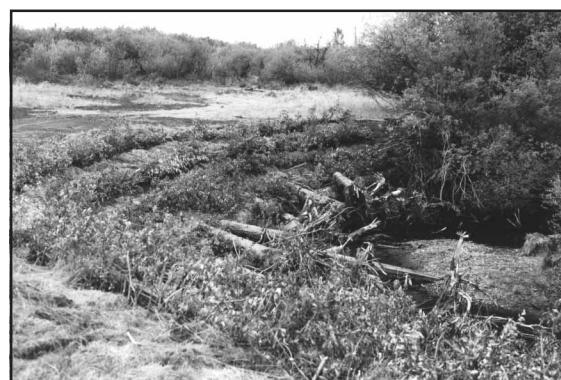
Figure 7-21b. After restoration of an eroding bank.

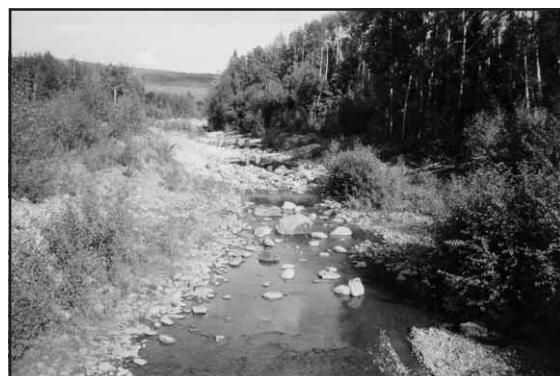
Figure 7-27. Upstream view of channel (from FSR bridge) after riffle-pool construction and LWD placement.

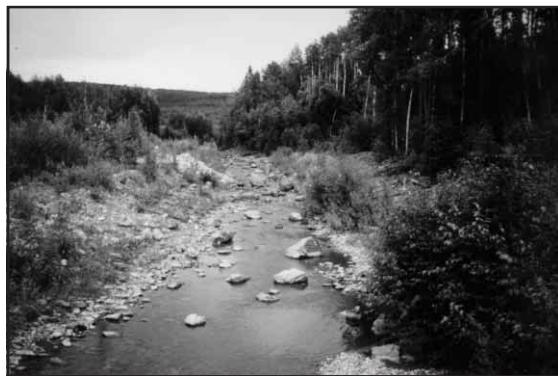
Figure 7-26. Upstream view of channel (from FSR bridge) before riffle-pool construction and LWD placement.

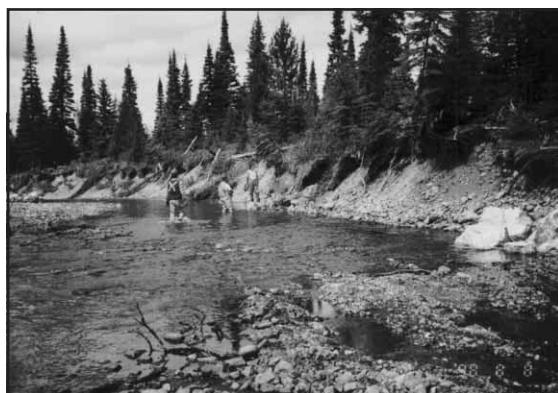
Figure 7-31. Pre-restoration downstream view of large eroding bank along Narrowlake Creek mainstem.

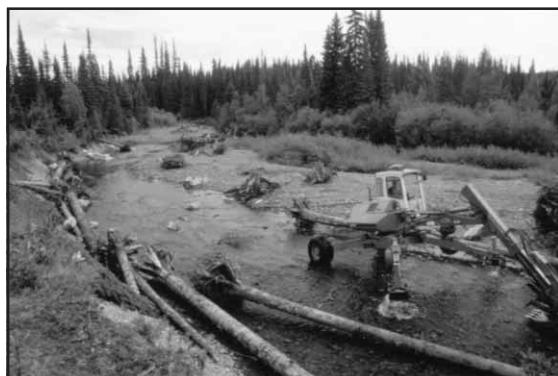
Figure 7-32. Mid-restoration upstream view of large eroding bank along Narrowlake Creek mainstem. Note LWD revetment and rock groynes under construction.

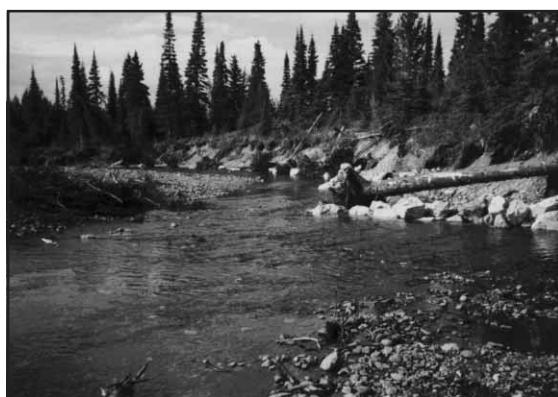
Figure 7-33. Post-restoration downstream view of large eroding bank along Narrowlake Creek mainstem. Rock groynes were colonized by juvenile rainbow trout within days of structure completion.

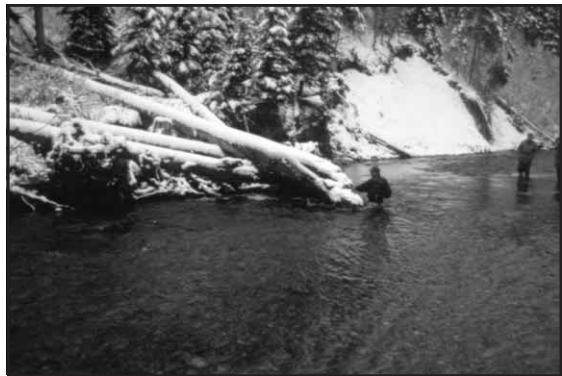
Figure 7-34. Post-restoration view of lateral LWD jam. Note depth of pool scoured out after October rainstorms. Large woody debris cover in pools is increased on average 20% following restoration.
