Summary of Minnow trapping component of the SD 91/UNBC eDNA project

2022 Season

Project Overview

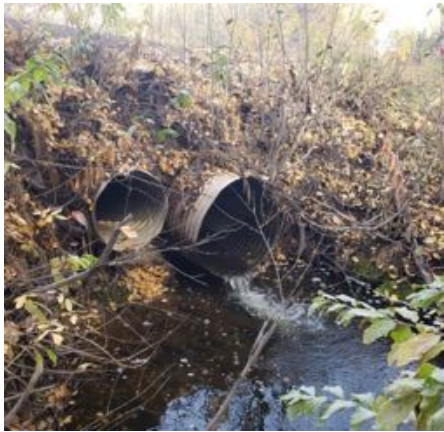
Photo 1. Perched culverts at Dog Creek FSR.

Over three trapping sessions we caught 10 chinook in a small section (~ 130 m) of Dog creek that extends from just above a set of culverts that cross the of Dog Creek Forest Service Road to the confluence with the Nechako River (Appendix 1). Of note in 2022 were the following observations. First, we captured chinook upstream of the perched culverts (Photo 1) and the small chute / waterfall below the culvert (Photo 2). These were thought to be barriers to upstream movement at lower flows in 2021. Clearly, our results this year have indicated that chinook were able to cross these structures during some point prior to our sampling in 2022. Second, we noted cattle activity on the section of Dog Creek above the Dog Creek FSR (Photo 3), and in fact one trap was disturbed by cattle. This activity resulted in a dramatic increase in turbidity of the lower section of Dog Creek in our August trapping session compared to our June and September trapping sessions.

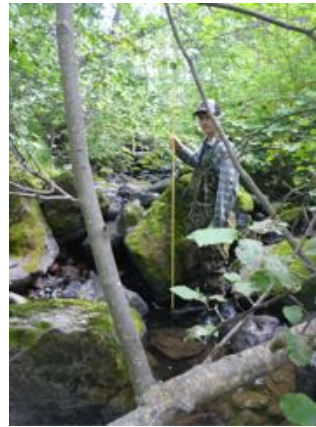
Photo 2. Cascade/chute at upstream end of Reach 1 on Dog Creek.

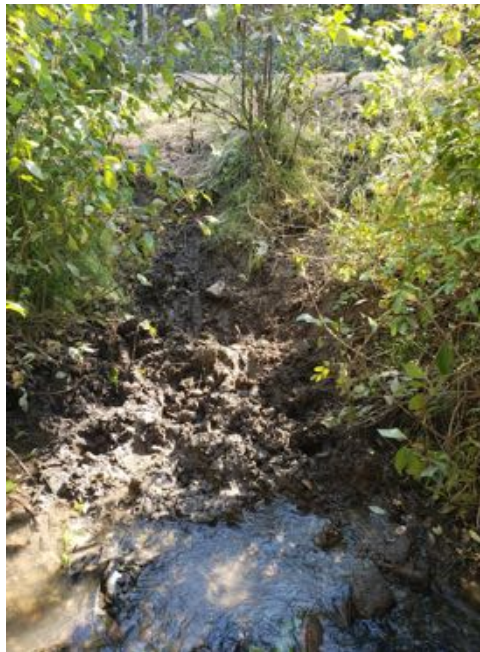
Photo 3. Sign of cattle accessing Dog Creek above the Dog Creek FSR.

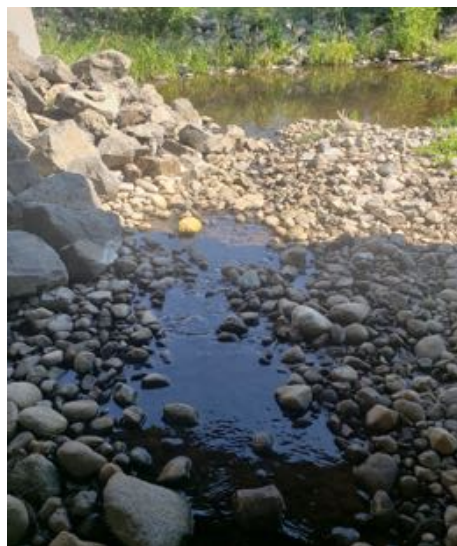
Photo 4a Looking downstream from beneath the bridge on Moss Creek, August 24, 2022. The plunge pool that formed because of the previous culvert can be seen in the background

Again in 2022 numerous chinook were caught on Moss Creek, although none were located upstream of the newly installed bridge on this creek. Flows were low during the times that we sampled (Photos 4 a, b, c), but there appeared to be sufficient water flowing under the bridge to facilitate the movement of fish between these two sections of the stream in late August. Movement of fish between these two sections was uncertain in late September due to even lower flows (Photo 4c). This situation should be monitored throughout the season to determine if these two sections are cut off from one another and if this may require further attention.

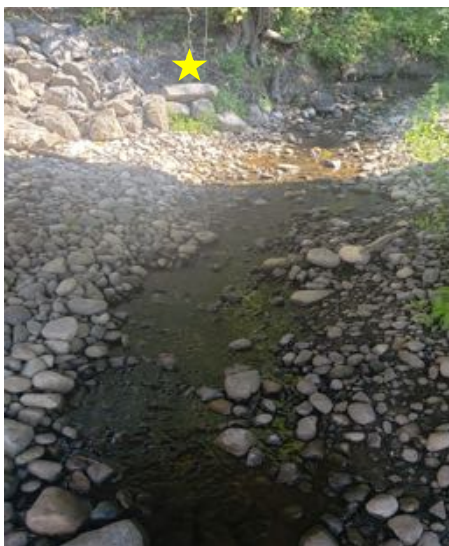
Photo 4b Looking upstream from beneath the bridge on Moss Creek, August 24, 2022. The yellow star in the background of photos 7 b and 7c is for reference.

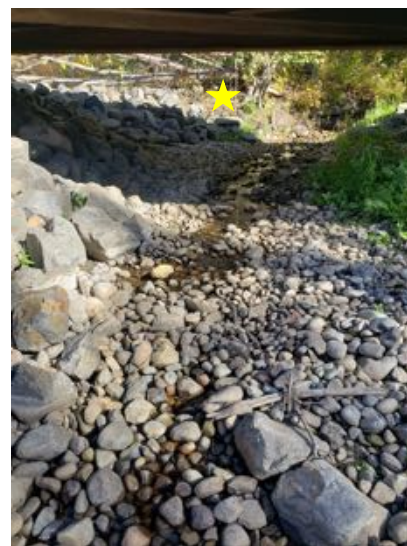
Photo 4c Looking upstream from beneath the bridge on Moss Creek, September 26, 2022

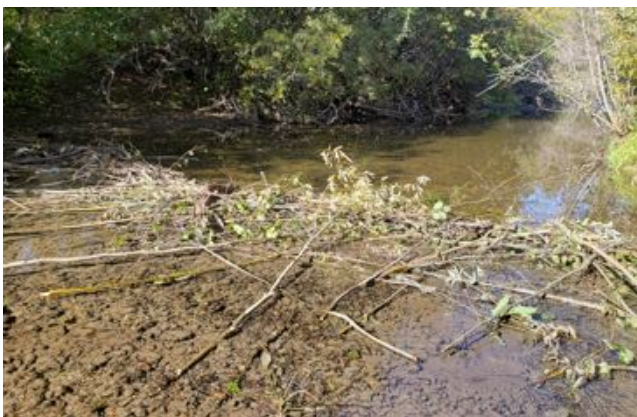
Photo 5. Beaver Dam spanning Ormond Creek.

Note water pooling above dam in Photo 5 and large (~ 15 cm) fish that appeared to be a rainbow trout staging at downstream end of dam in the foreground of Photo 6.

We noted that a small beaver dam spanning Ormond Creek in the vicinity of where we placed our traps had been constructed between our August and September sampling sessions (Photo 5 & 6). While this beaver dam will not persist on this section of Ormond Creek given width of the creek at this location, and the high flows we have seen in the past, it nonetheless had localized and temporal impacts: water was clearly backing up behind the dam; and a large rainbow trout was seen staging downstream of the dam when we arrived and its upstream movement appeared to be hindered by this small dam (Photos 5 & 6). It was also noted that some attention downstream of the culverts that cross Stella Road may be warranted. We noted that there have been significant alterations to the channel morphology downstream of the culverts. While we did not thoroughly assess the section of Ormond Creek immediately downstream of the culverts for possible fish passage issues, but we feel that this is warranted given the current appearance of the channel (Photos 7-9).

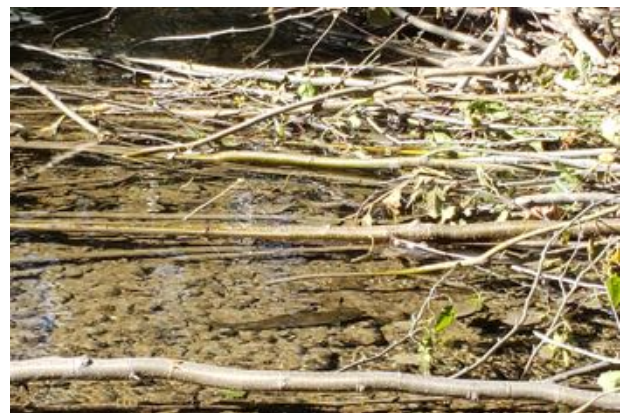
Photo 6. Close up of dam.

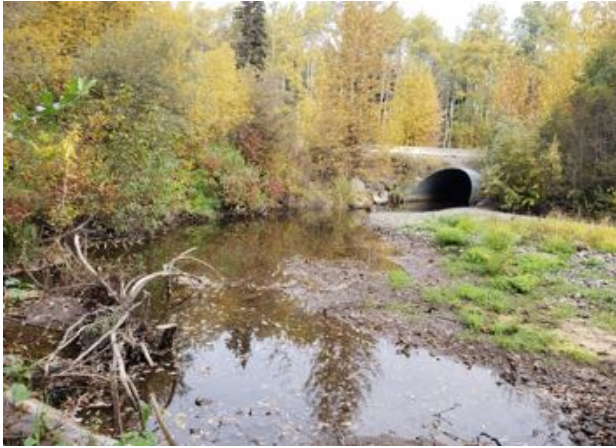
Photo 7. Ormond Creek

This photo is looking upstream to the culvert that crosses Stella Road. Note the sediment wedge on the right-hand side of the photo. This deposition is pushing most of the flow of Ormond Creek through the willows on the river right side of the creek (left hand side of this photo).

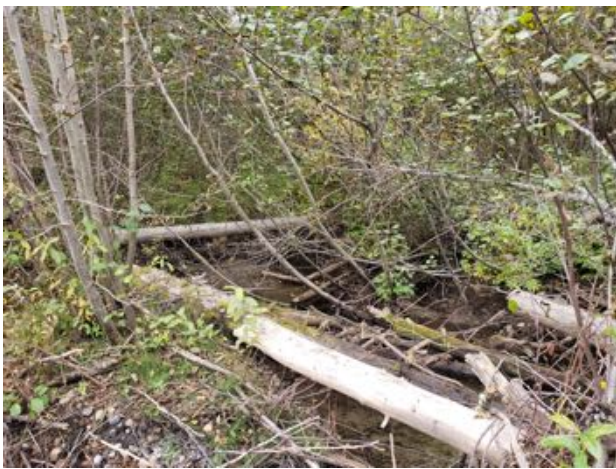
Photo 8. Ormond Creek through willows.

Although difficult to see in the photo, this is one of the paths Ormond Creek takes through the willows on river right. Of importance to note here is that the creek winds through at least one narrow channel that is somewhat clogged with logs and debris.

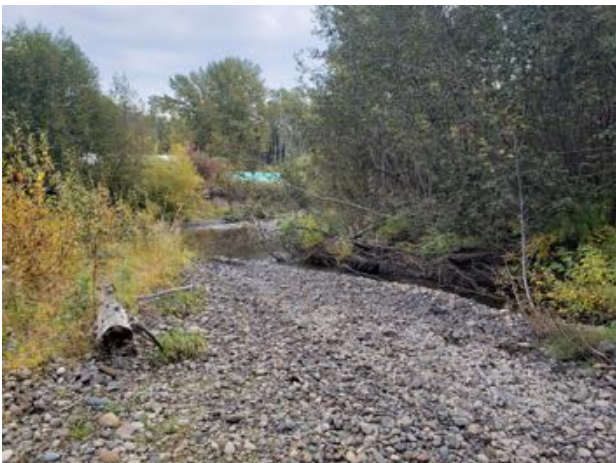
Photo 9. Ormond Creek emerging from path through willows

This photo is looking downstream from Photo 7. One can notice the large accumulation of bedload in the foreground. It can also be seen that the flow of the creek reappears down stream

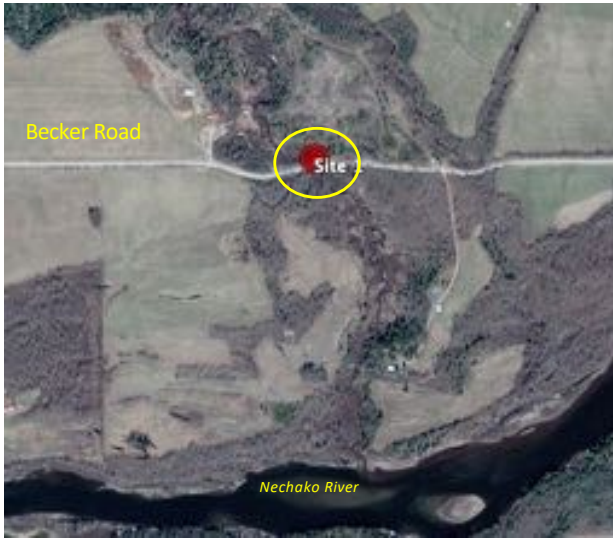
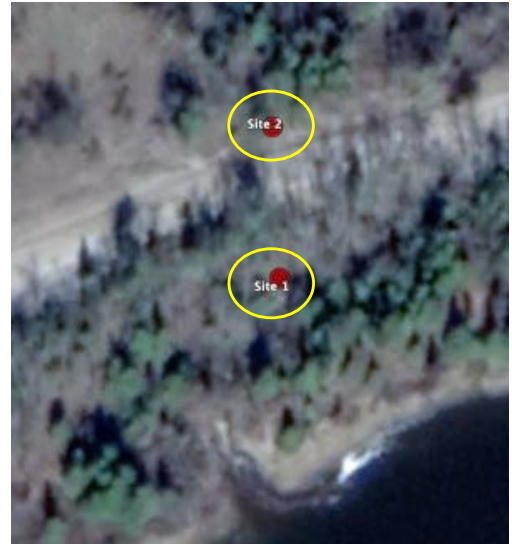
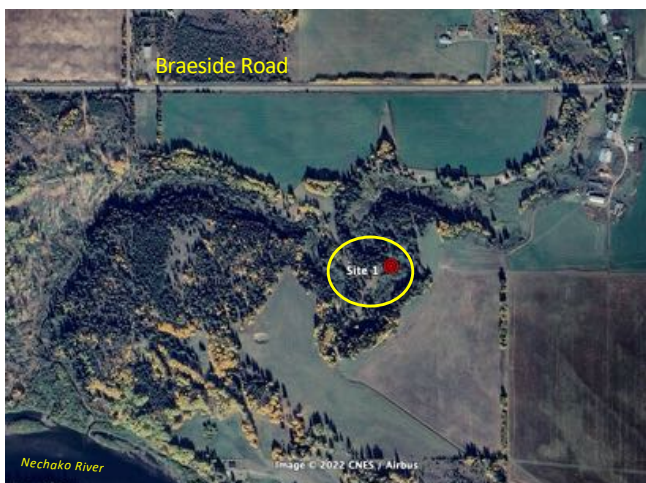
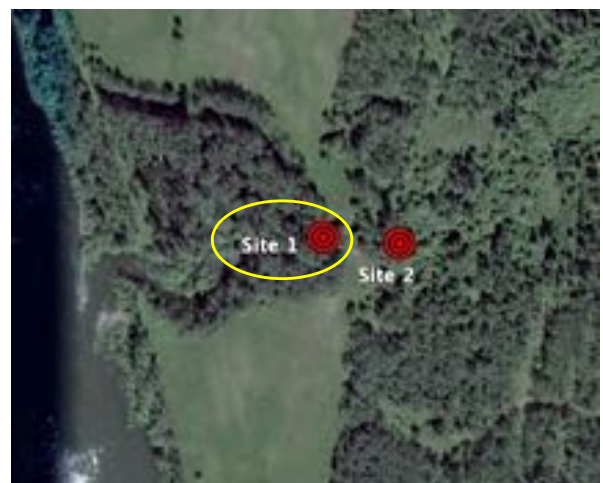
Figure 7. Sites where chinook salmon were caught

Sites where chinook were caught are circled in yellow

We caught a total of 59 chinook salmon during our trapping efforts. Chinook were caught in 4 of the 11 creeks that we sampled. Chinook caught ranged from 50 to 90 mm in length and weighed between 2 and 8 grams (Table 2). Locations of where chinook were caught on each creek can be found in Appendix 1.
