Stoney Creek

Preliminary Watershed Health Assessment

Olin Albertson R.P.Bio
Avison Management Services Ltd.
P.O. Box 774
220 East Stewart St.
Vanderhoof, B.C. V0J 3A0
Ph: (250) 567-2111

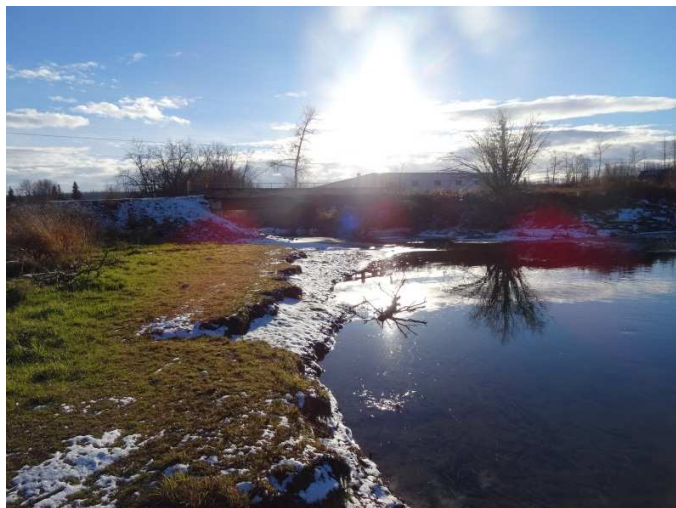
Photo 1: Stoney Creek/Nechako River Confluence

Background: Old cars, airplane parts, scrap metal, and concrete have been dumped at this site many years ago to help prevent erosion and stabilize the bank.

It is currently unknown who is responsible for these actions. What is known is that this site is in need of attention and remediation efforts should be considered. The old cars, scrap metal, concrete, garbage and debris should ideally be cleaned up and removed from the river if this can be done with minimal disturbance to the river substrate and bank, and with minimal sediment suspension instream. The old cars, airplane parts, scrap metal, and concrete have had some functionality in reducing erosion and providing bank stability and should be replaced with approved acid free rip-rap to prevent erosion and provide bank stabilization.

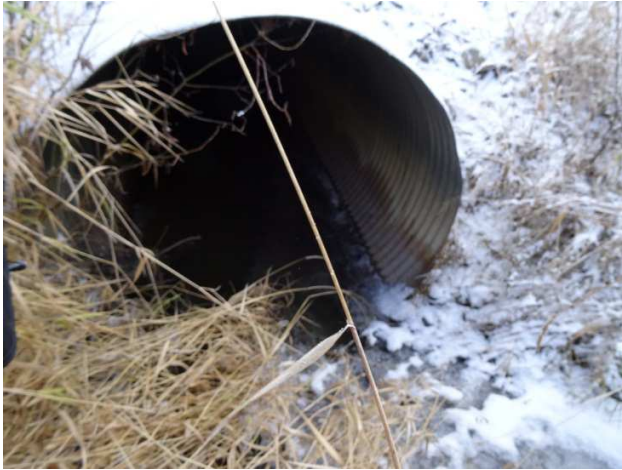
Picture 1: Culvert Inlet

There are two closed bottom culverts at this site, one main culvert, and a smaller overflow culvert. The stream width ratio for this culvert indicates it is inadequate for this stream. In addition, some of the other assessment attributes (culvert length, embeddedness, and slope) make this culvert score as a barrier to fish. There was no evidence of washouts occurring, or severe erosion in past years. There is little evidence of beaver activity near the culvert. This culvert scores as a barrier and should be replaced.

- 1) Take out these culverts during low flow and replace them with a bridge.
- 2) Replace these culverts with a large diameter open bottom arch culvert that will handle freshet flows and will not impede fish passage.
