Omineca - Peace Region

Region 7. Omineca-Peace

Spruce Creek Stream Restoration Project: Horses and Helicopters

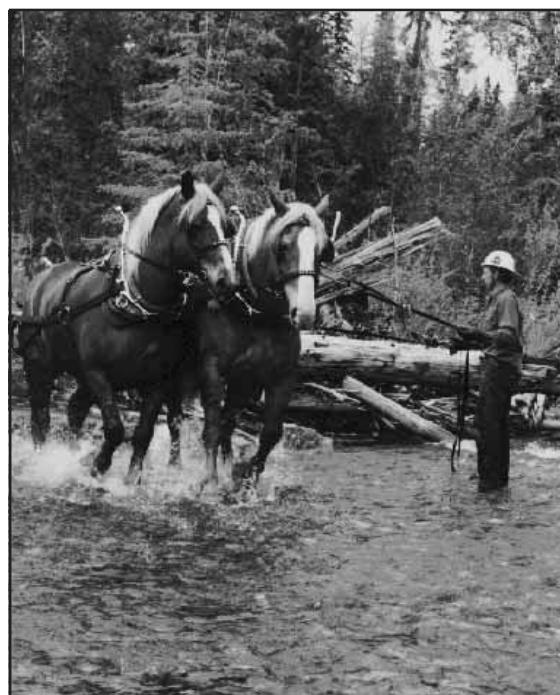
Figure 7-1. Both phases of the project involved manual labour and “George and Red”, a team of draft Belgian horses, to position the structures in prescribed locations.

Large woody debris and rootwads were transported to the project site via self-loading logging trucks. In Phase 1, all wood was placed instream using two Belgian draft horses "George and Red" (Fig. 7-1). In Phase 2, all materials were located in a central landing site and transported to each structure site via Bell 205 logging helicopter and exact positioning of materials was done by manual labour and the two draft horses. Wood at the cutblocks was moved to loading sites with a grapple skidder.

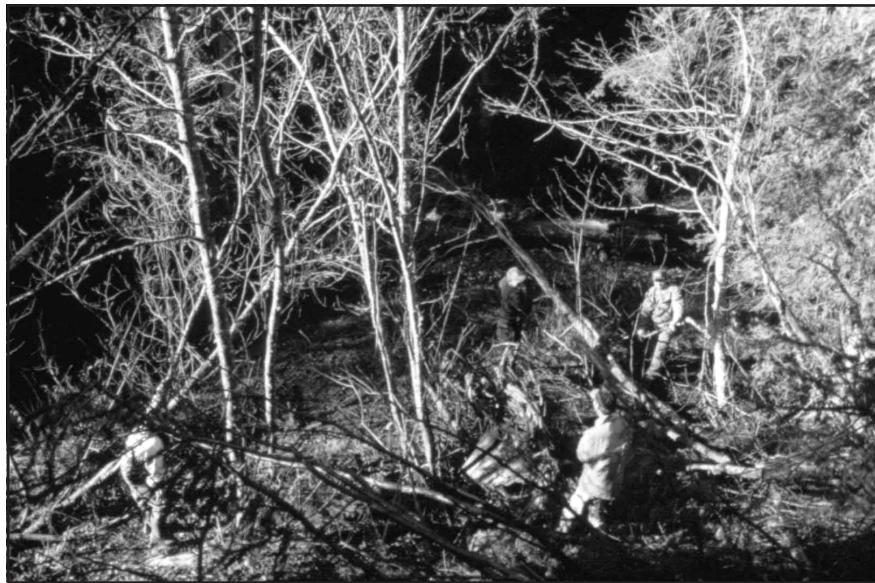
Figure 7-12. Manual labourers from Lheidli T'Enneh First Nation maneuvering large woody debris into McPhee Creek with winches and block and tackle.

The collapsed bridge removal and access deactivation was completed with an EX 220 John Deere excavator. Along treatment Reach 2, LWD was moved by the use of labourers from the Lheidli T’Enneh First Nation. This was accomplished with block and tackle pulley systems, and an 8000 lb truck winch (Fig. 7-12).

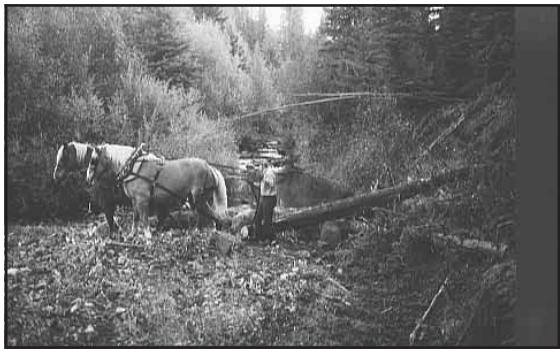
Figure 7-22. Draft horses placing LWD.

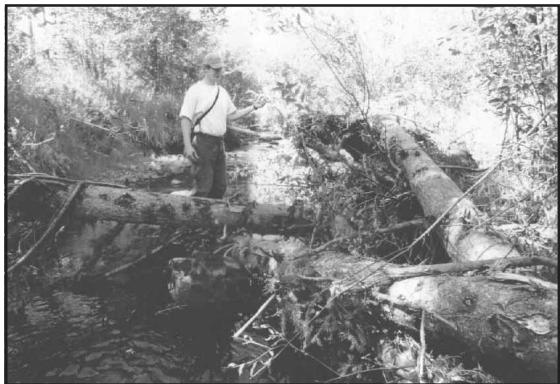
Figure 7-23. Lateral debris jam.

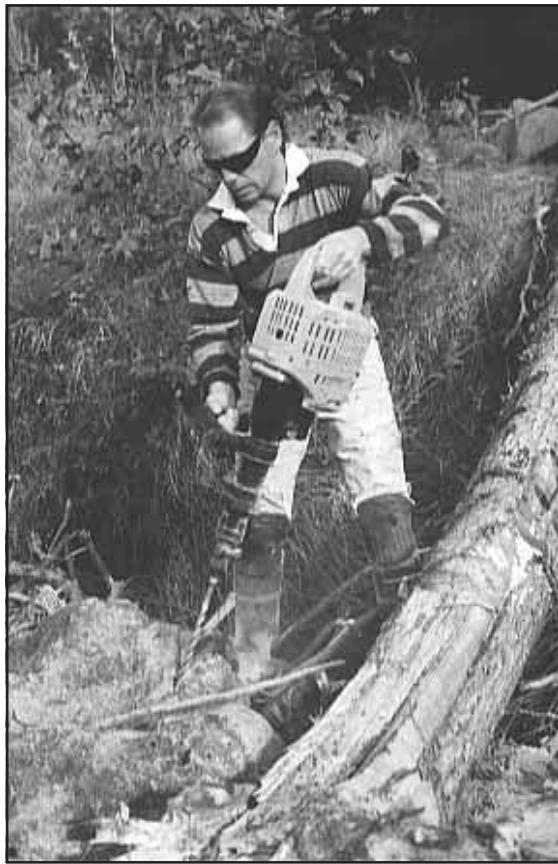
Figure 7-24b. Anchoring LWD structures.

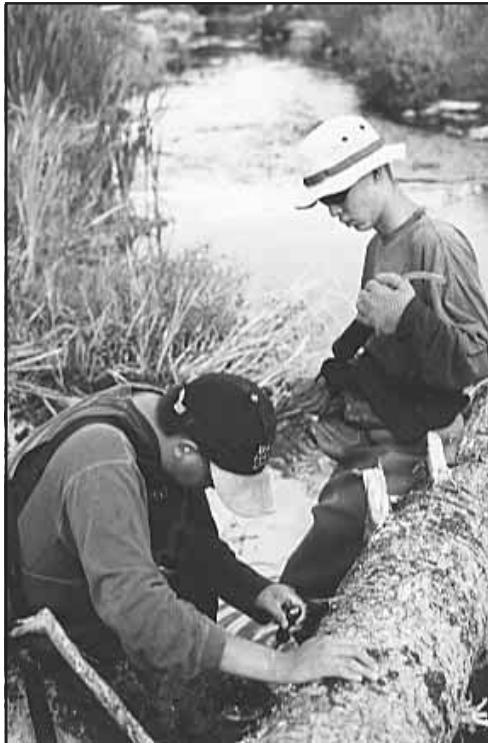
Figure 7-24a. Anchoring LWD structures.

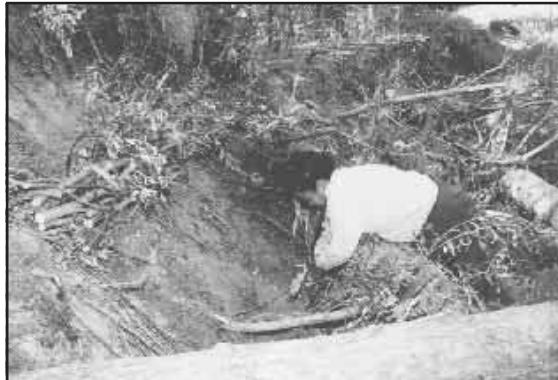
Figure 7-25. Willow wattle and brush layer placement.

In these same reaches of Corkscrew Creek, 200 linear m of streambank were stabilized, covering an area of 0.42 ha. Bioengineered slope stabilization strategies were designed after Babakaiff et al. (1997) to re-establish willow and cottonwood on riparian banks and to stop further erosion. Willow wattles, brush layers, live stakes and willow mattresses were assembled and put in place by a crew of six Saik'uz First Nation technicians through August and part of September (Figs. 7-21b and 7-25). Additionally, a riparian planting program, carried out by nine Saik'uz First Nation students, planted 20,000 spruce and 88 alder seedlings, as well as 16,185 willow and 15,519 cottonwood whips. These were planted throughout the watershed specifically, in areas where past logging practices

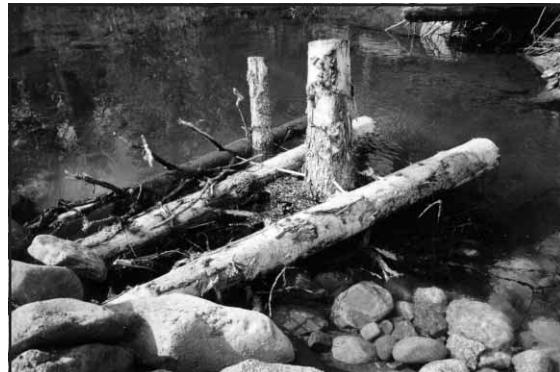
Figure 7-28. LWD structure constructed over a pool excavated below riffle #8.

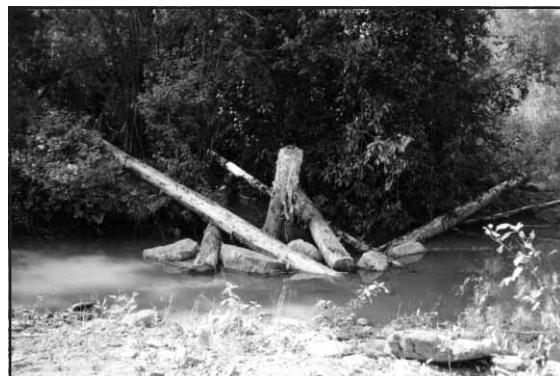
Figure 7-29. Low profile LWD structure designed to maintain pool habitat through bed scour.

- at bankfull stage thereby preventing further downcutting of the streambed.
- Construction of 14 low profile LWD structures in the mainstem (Fig. 7-29). They were generally multiple log structures arranged in a triangular geometry and ballasted with rock.

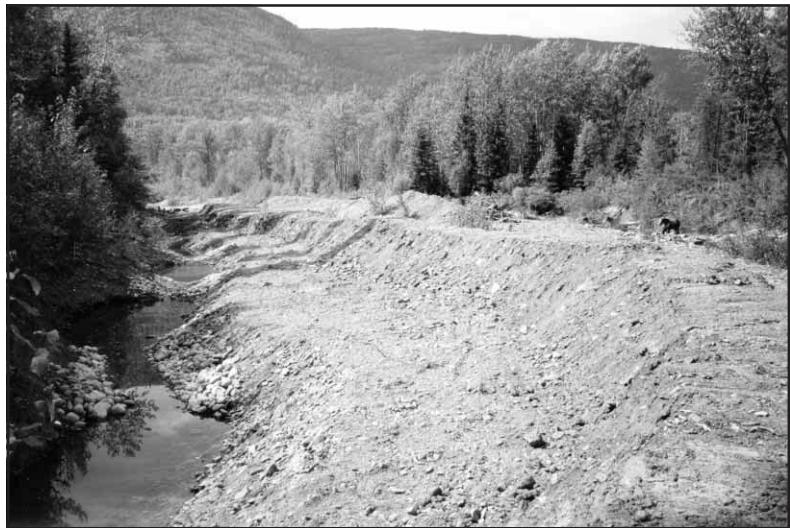
Figure 7-30. Side channel following its excavation to groundwater level and the berm protecting it from high mainstem flows.

- Excavation of an existing but elevated side channel down to groundwater level to ensure the channel will no longer de-water to a level that will strand and kill juvenile fish. The side channel is connected to the mainstem at the outlet end. The channel was reconstructed as a series of 7 shallow pools separated by short (5 m) riffle sections (Fig. 7-30). The newly excavated clay bed was lined with round rock (10 - 20 cm diameter) to provide more suitable substrate for fish and aquatic insect production.

- Construction of a berm between the mainstem and the side channel to protect the side channel during peak flows (Fig. 7-30).

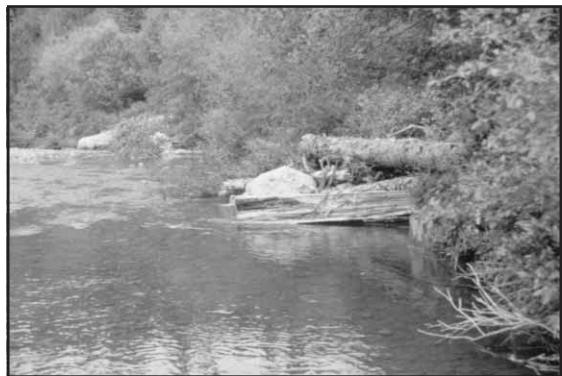
Figure 7-35 Post-restoration view of LWD / boulder deflector.

- 2 rock groynes (Figs. 7-31 to 7-33);
- 2 LWD revetments (Figs. 7-31 to 7-33);
- 19 single logs;
- 21 lateral (triangle) log jams (Fig. 7-34);
- 6 LWD flow deflectors (Fig. 7-35), and
- 16 gravel bar stabilization structures (Fig. 7-36).

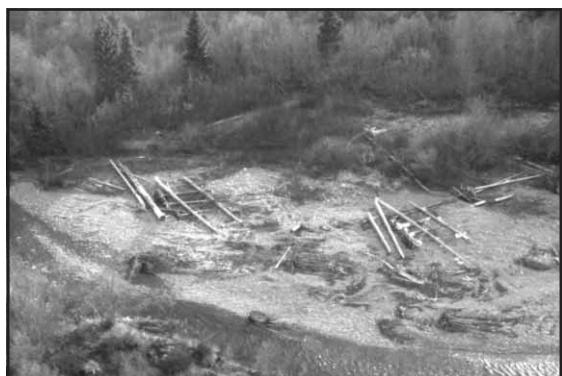
Figure 7-36. Post-restoration view of multiple lateral gravel bar stabilization structures in the lower reaches of Narrowlake Creek.
